BUREAU OF SHIPS GROUP TECHNICAL INSPECTION REPORT

U.S.S. INDEPENDENCE (CVL22)

TEST ABLE

VOLUME 4 OF 4

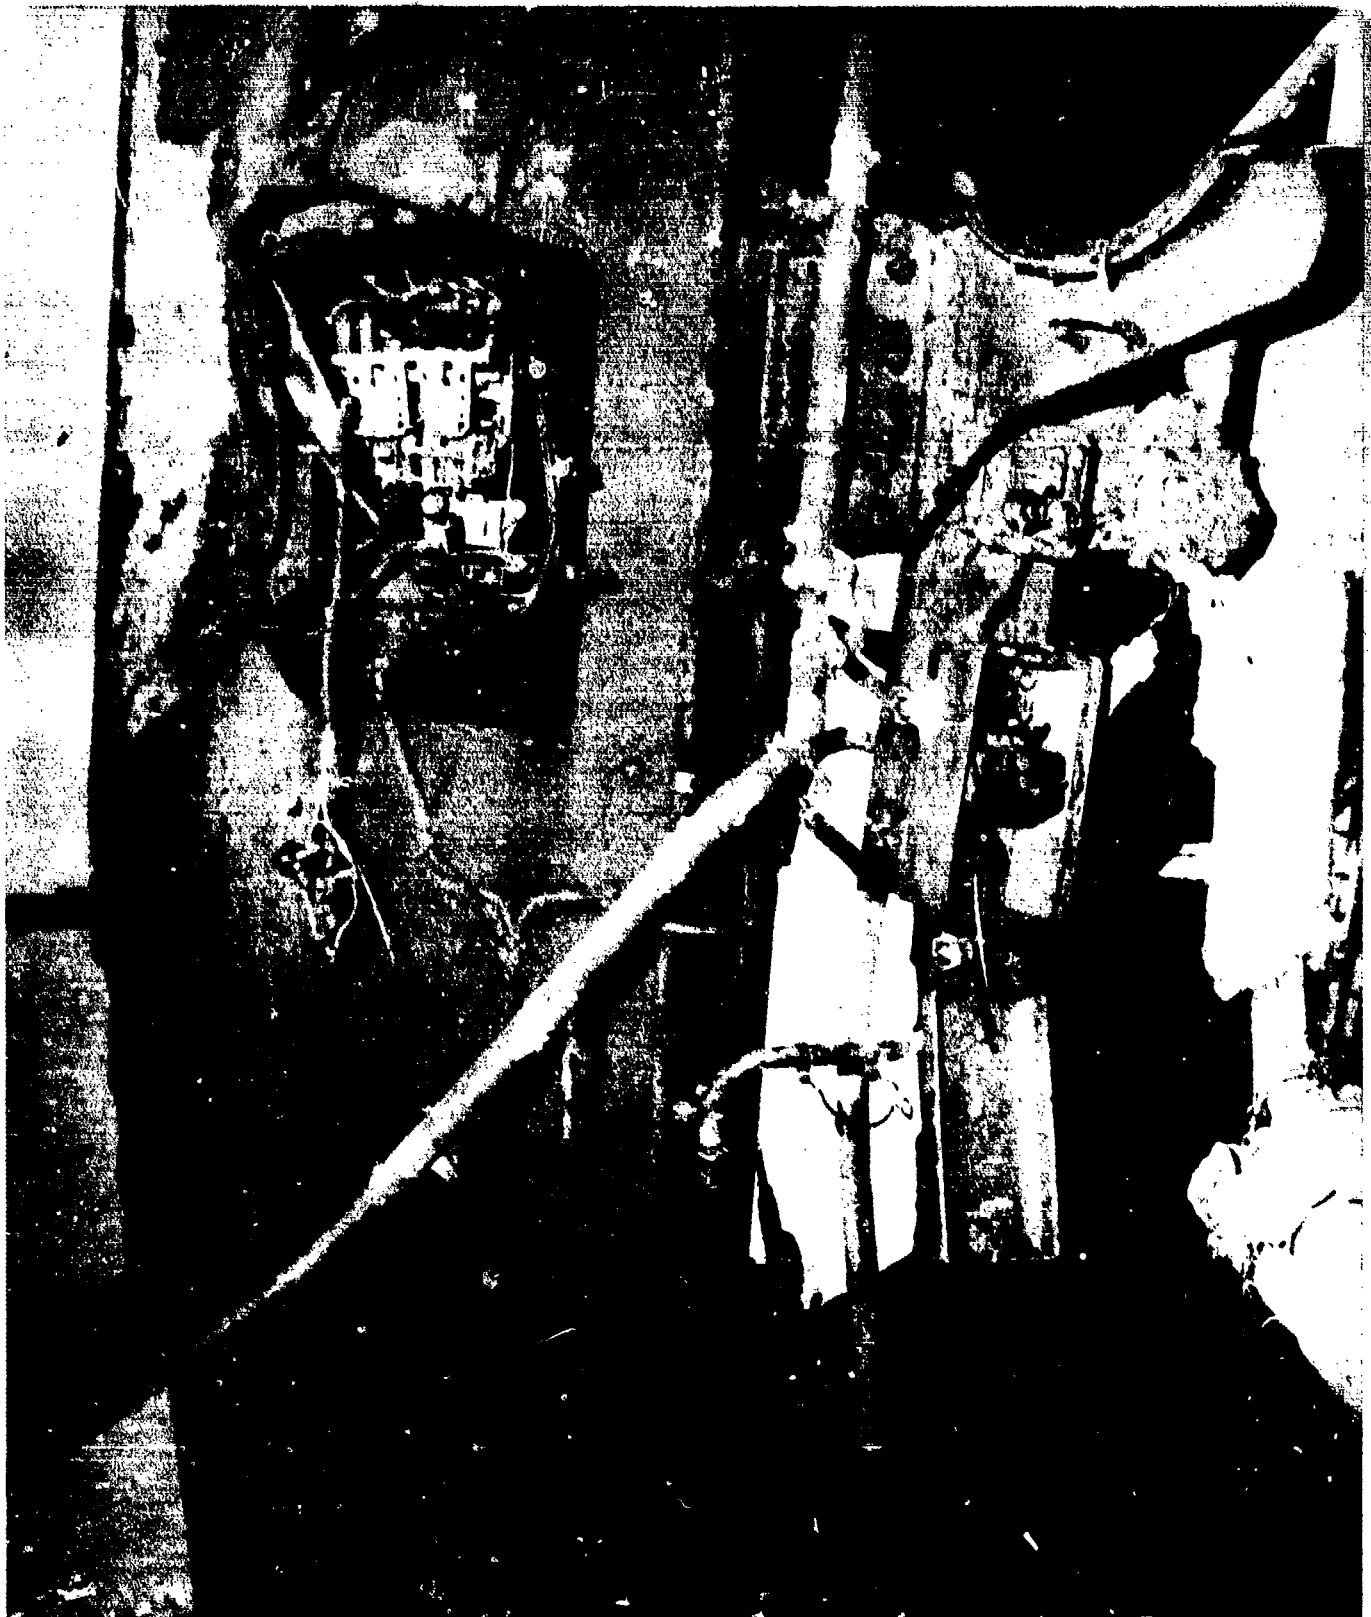
AA-CR-82-1918-6. Damage to ventilation controller and type "C" automatic telephone unit, located at frame 113 starboard side hangar space. View looking aft and outboard.

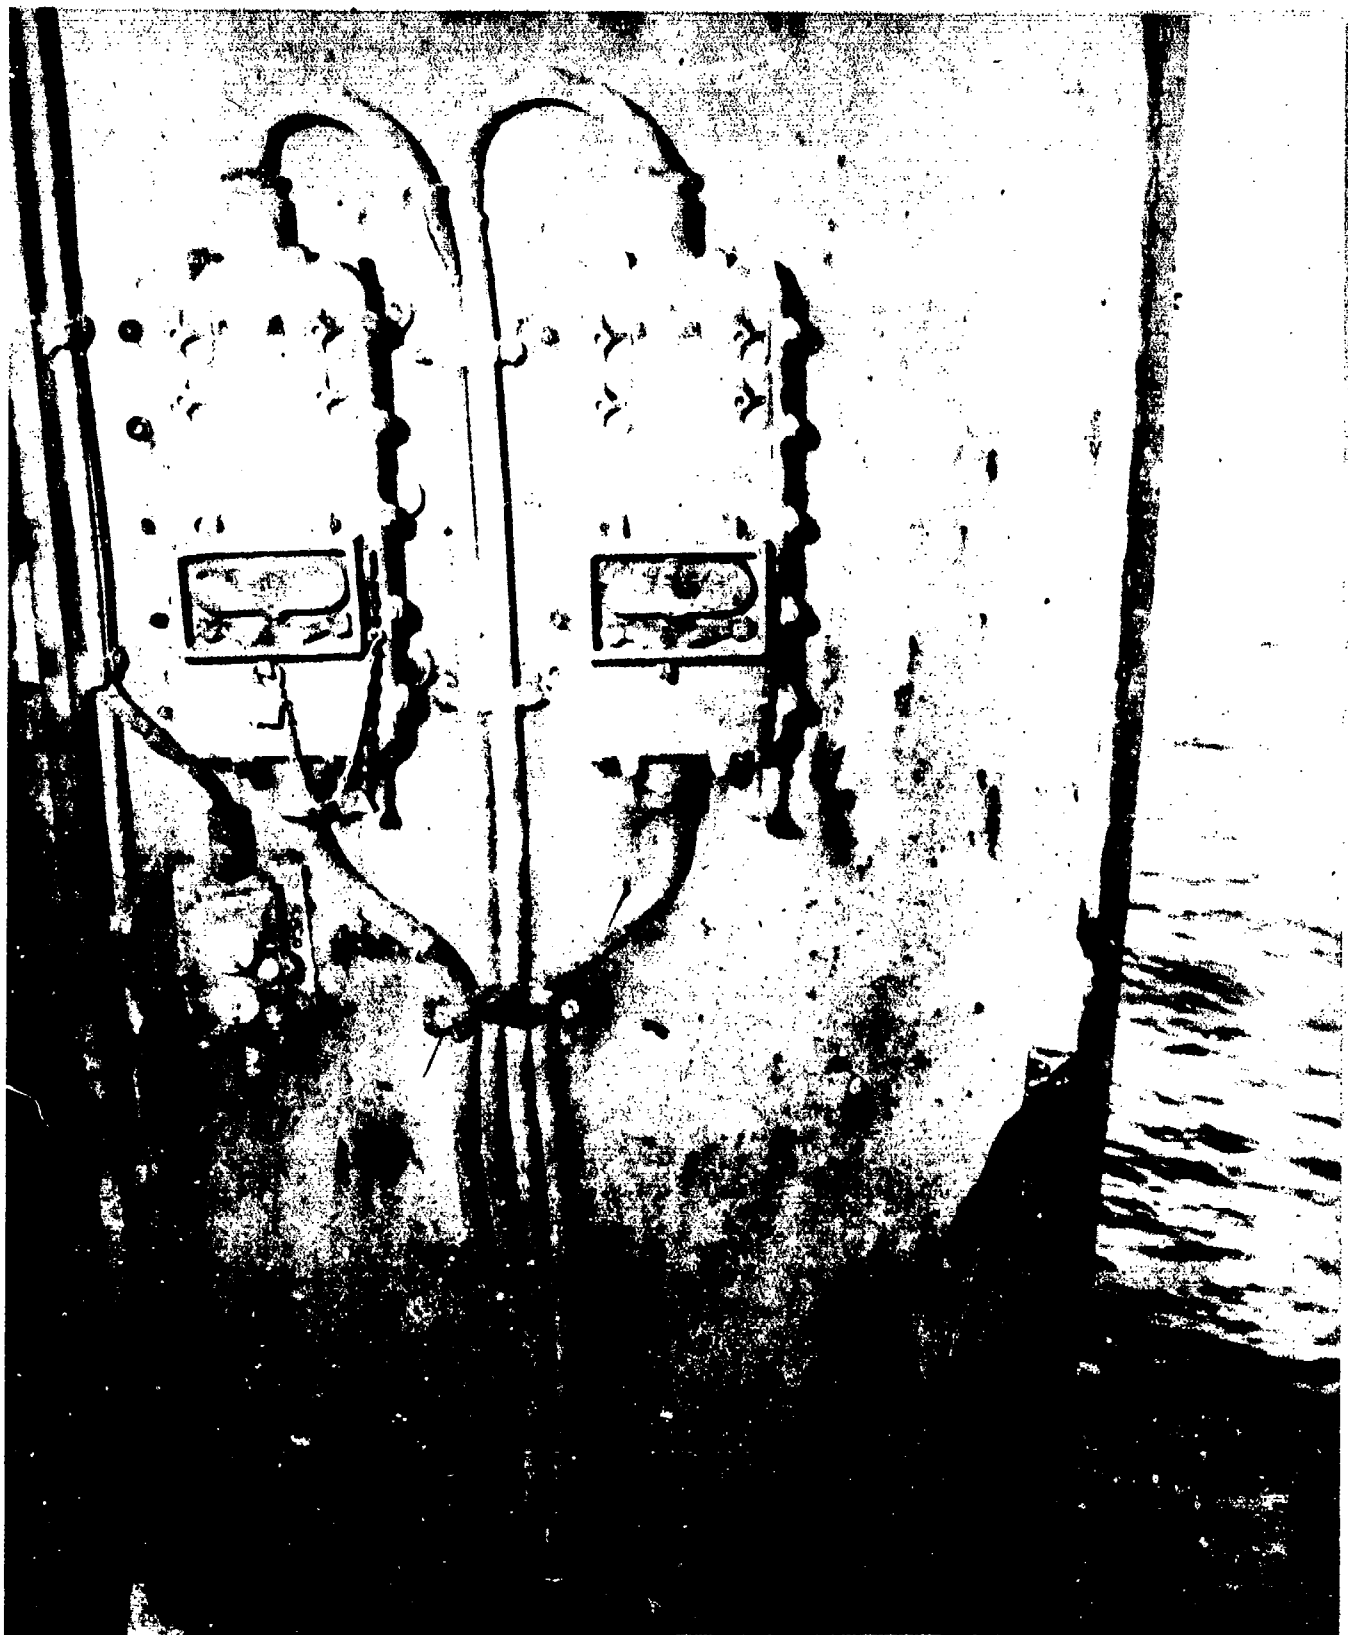
AA-CR-82-1918-8. Damage to cable at securing strap for water curtain control switches, frame 118 port side hangar space. View looking aft and outboard.

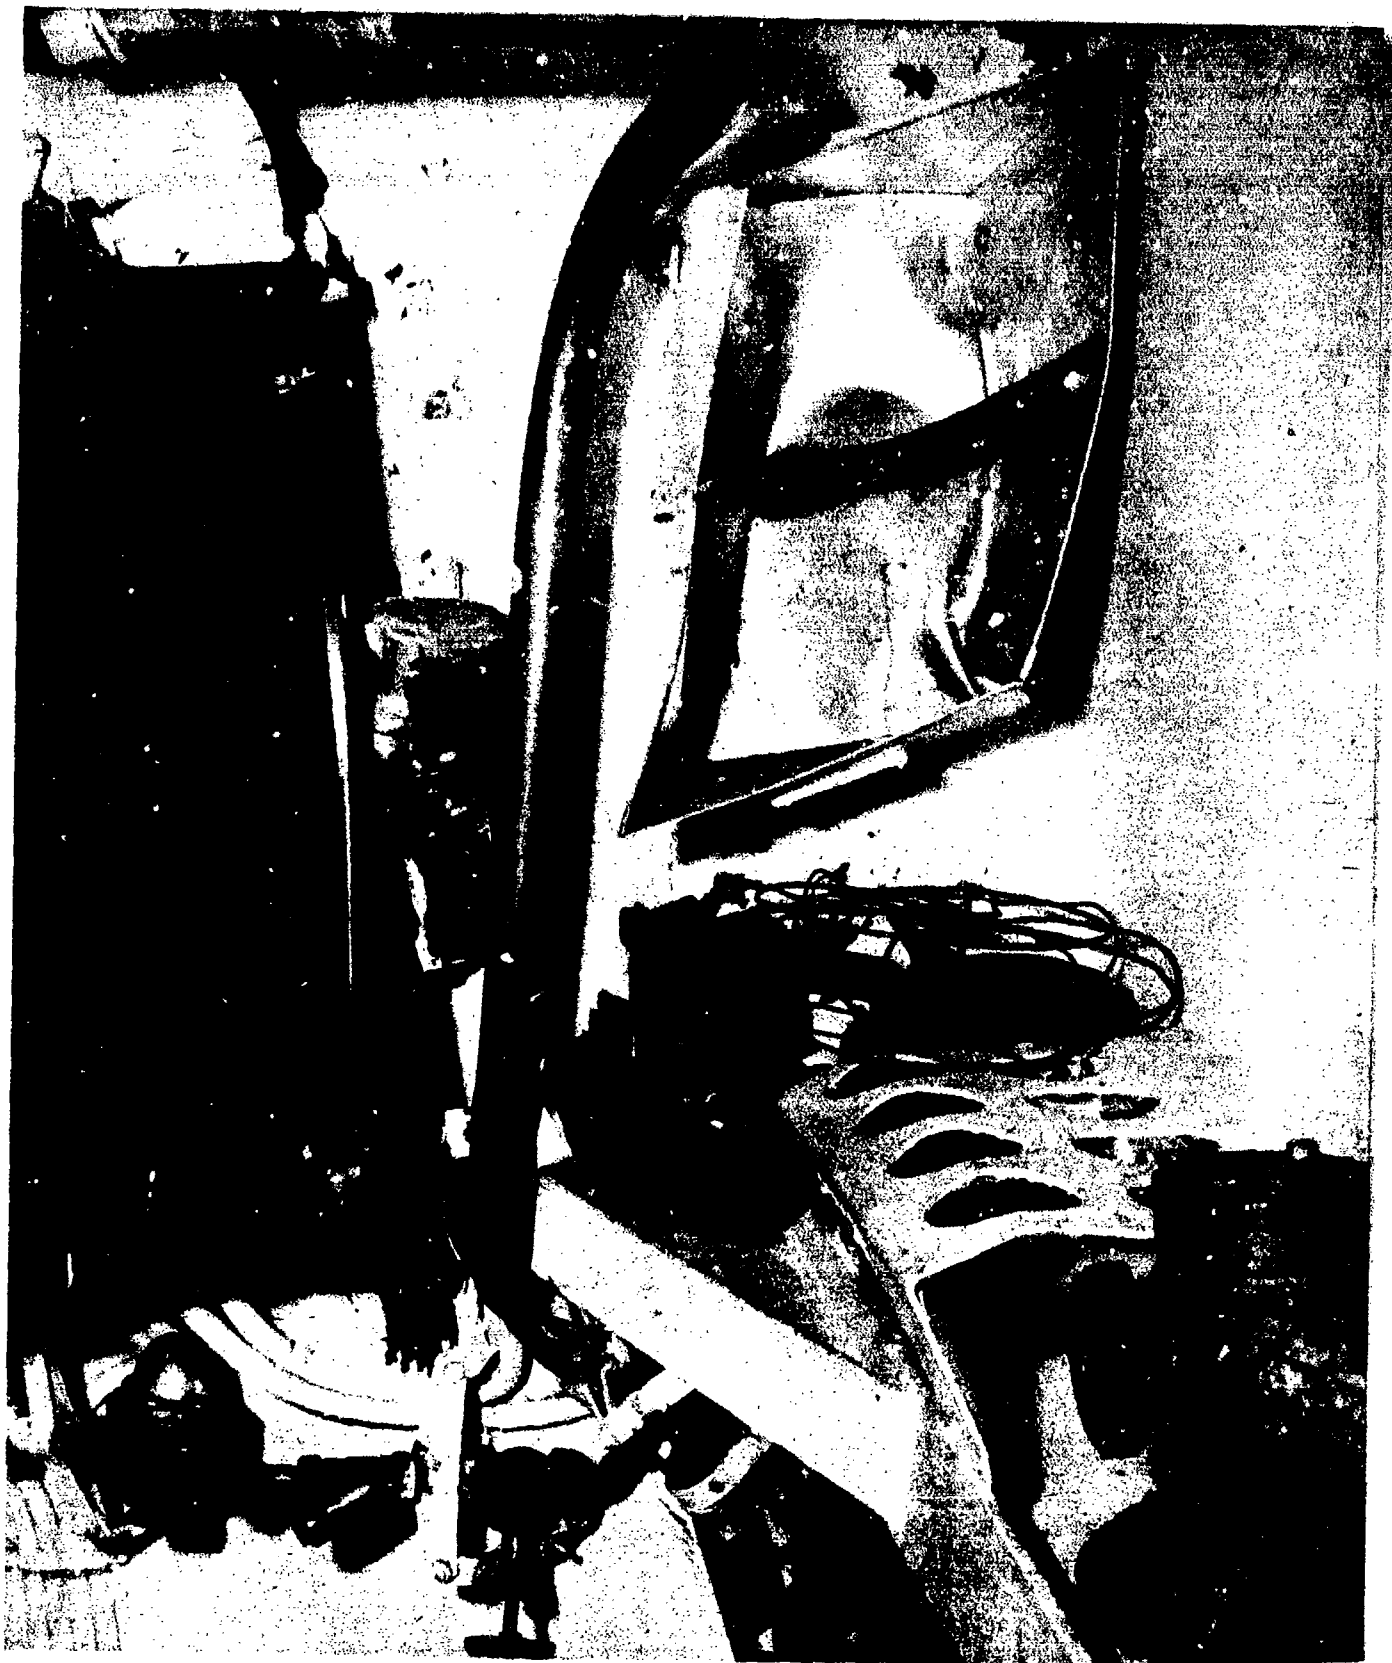
AA-CR-82-1917-1. Damage to control push button for refrigeration circulating pump motor No. 2 and electric fan on bulkhead 126 port side 3rd deck in ice machine room. View looking aft.

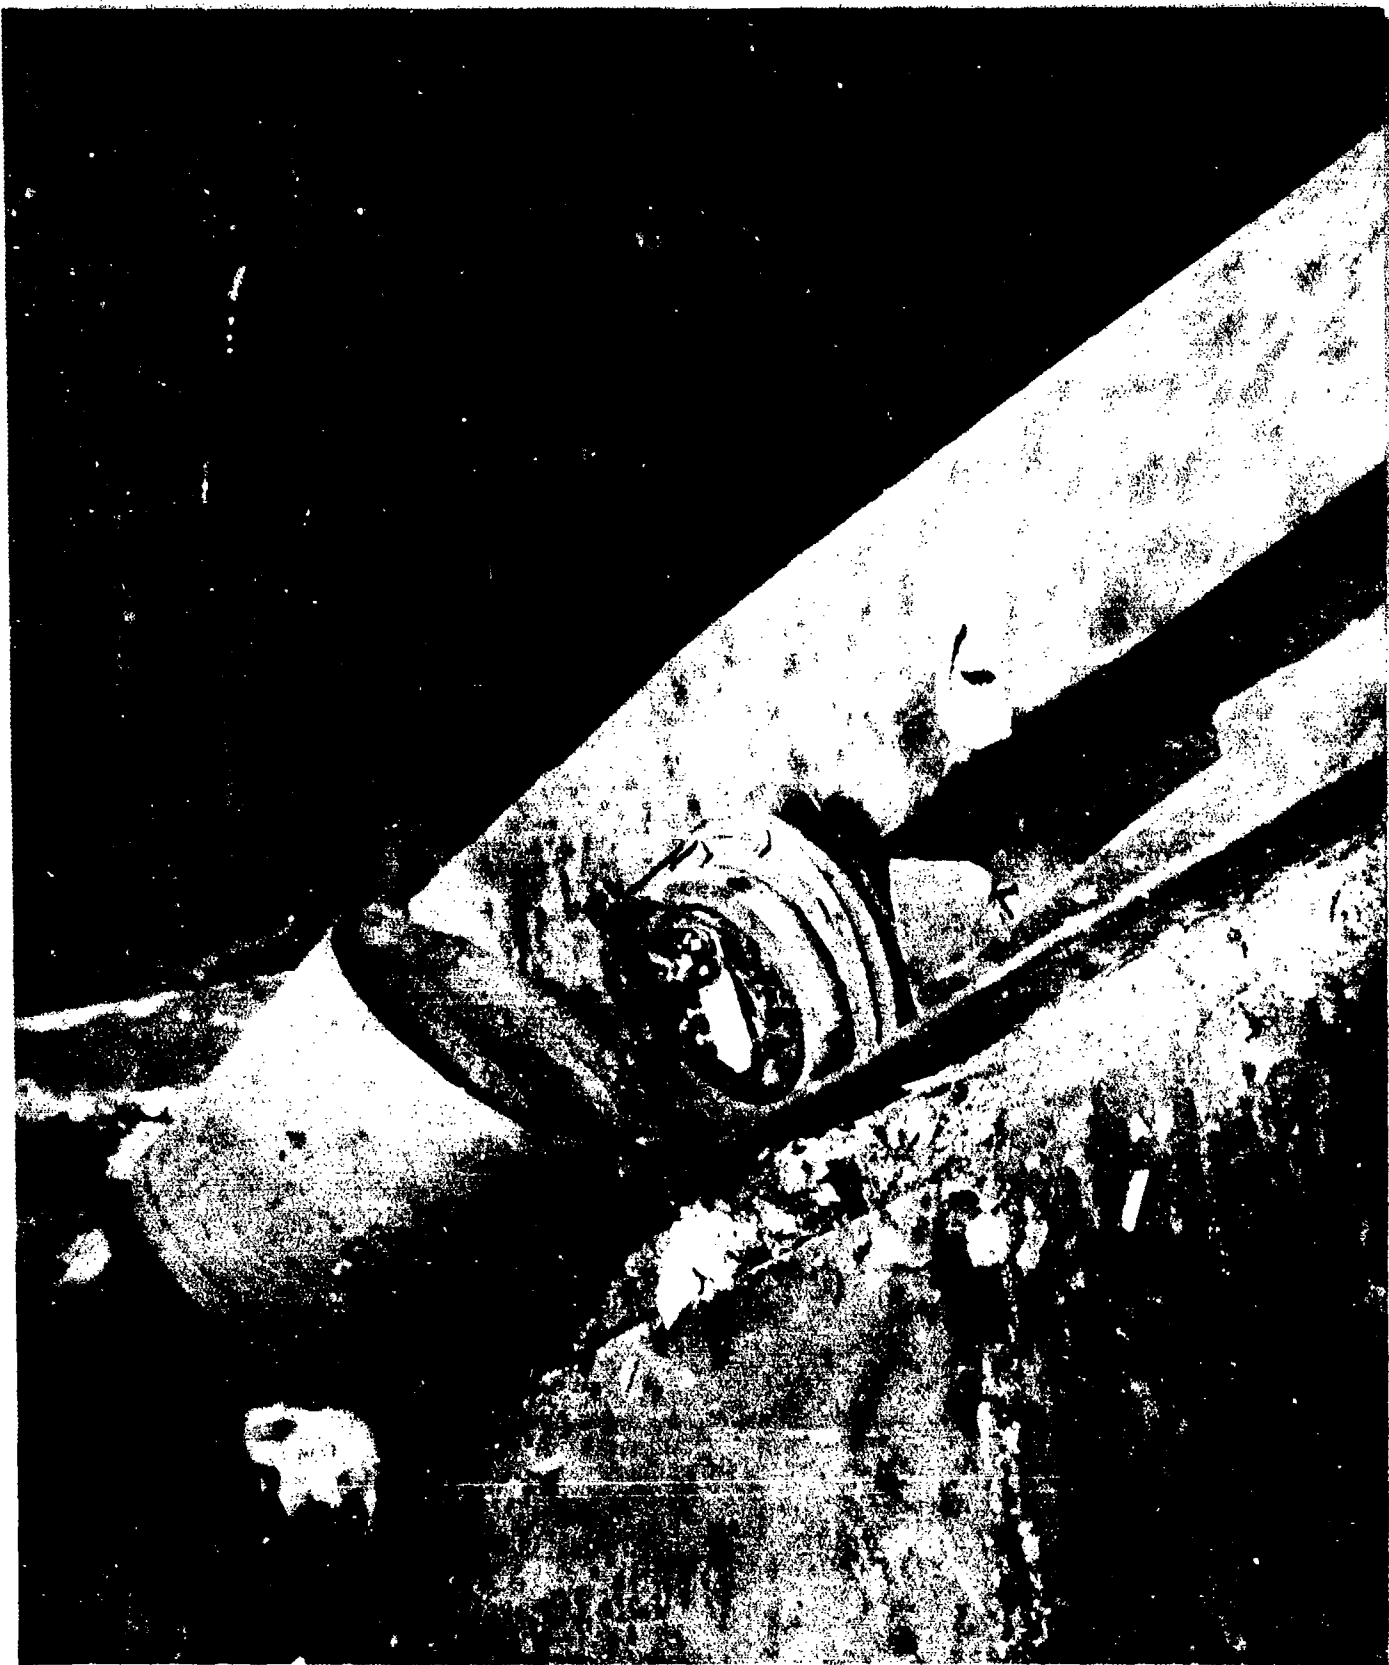
AA-CR-62-1881-4. Damage to deck edge landing light of frame 84 port side of flight deck, view looking aft and outboard.

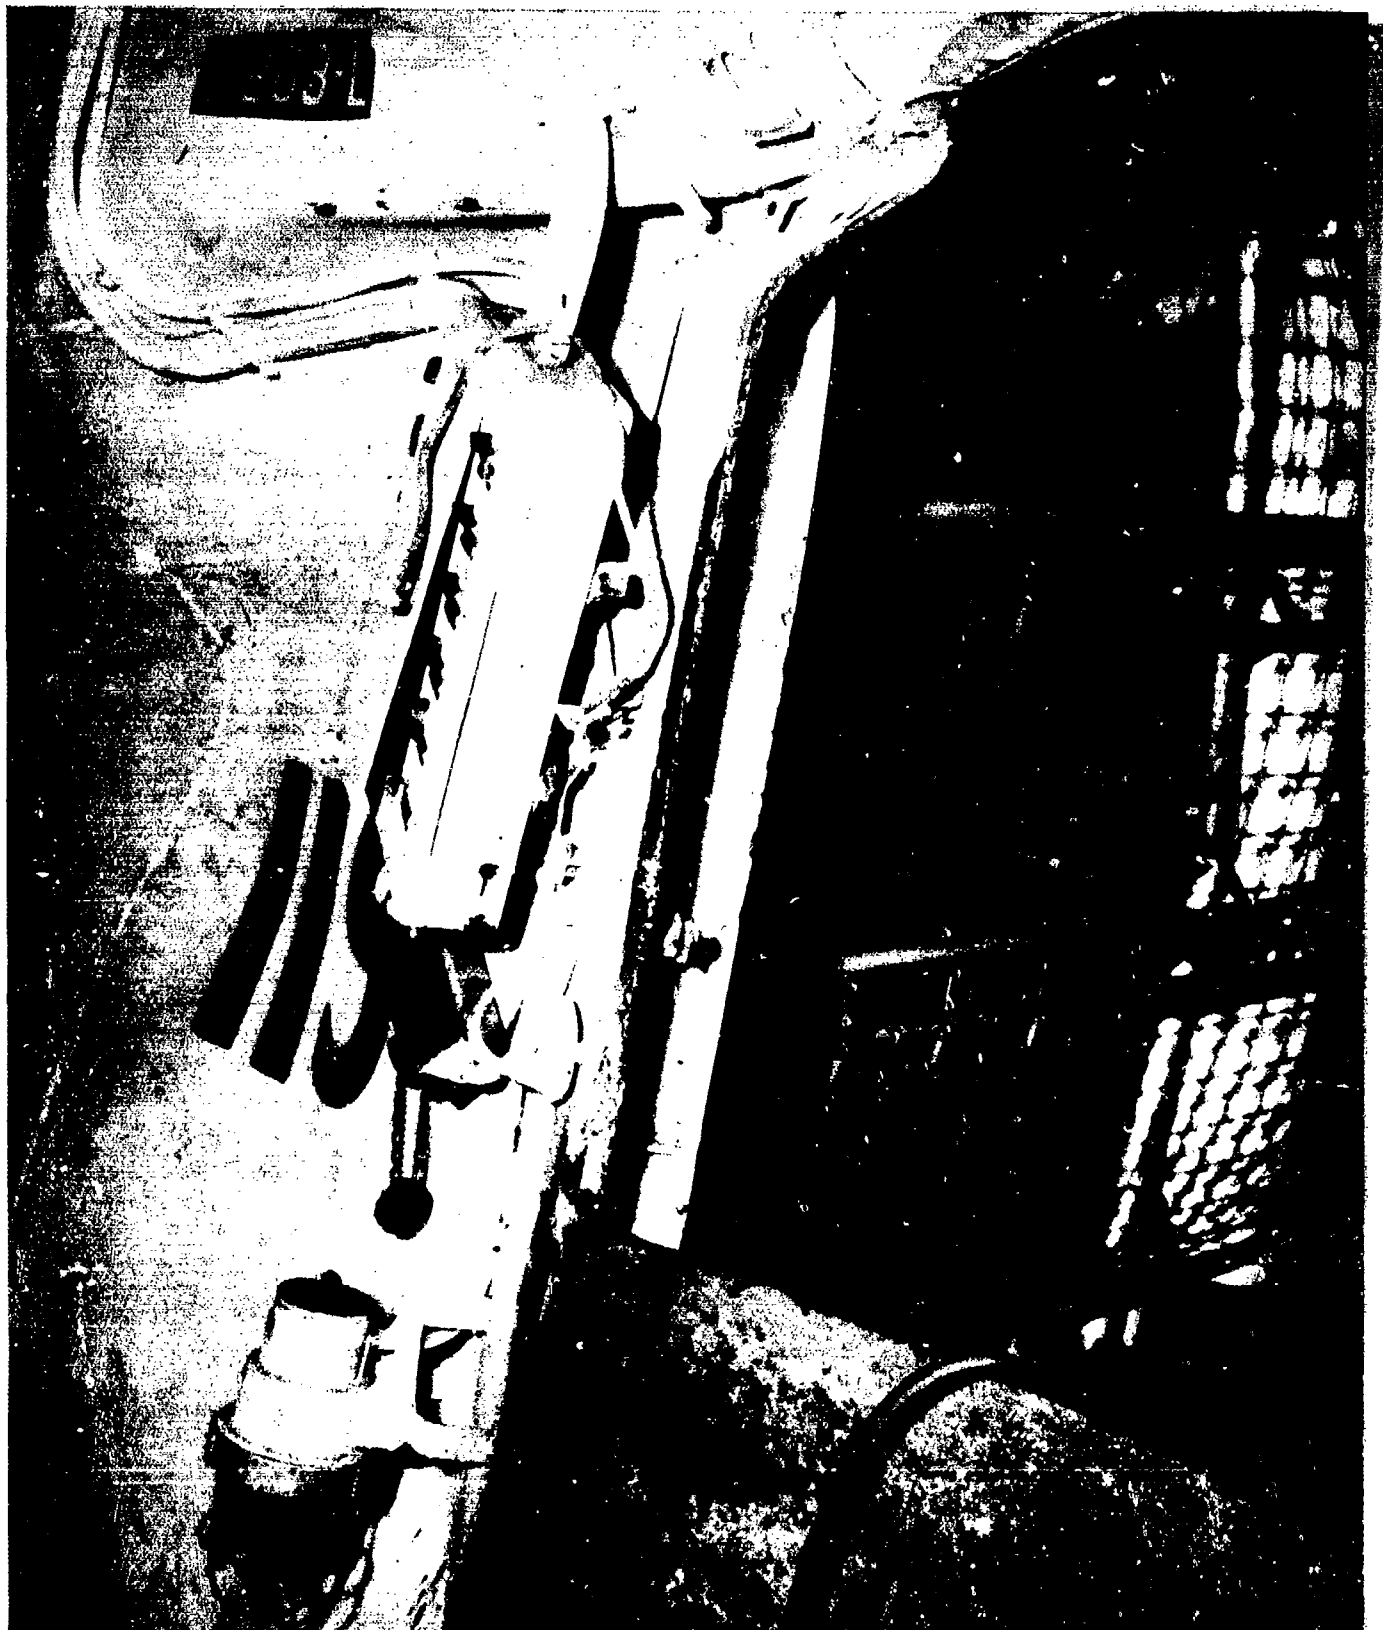
AA-CR-82-1916-8. "12T" lighting distribution box located on bulkhead frame 119 port side second deck mounting feet broken and cover distorted due to buckle in bulkhead. View looking forward and to port.

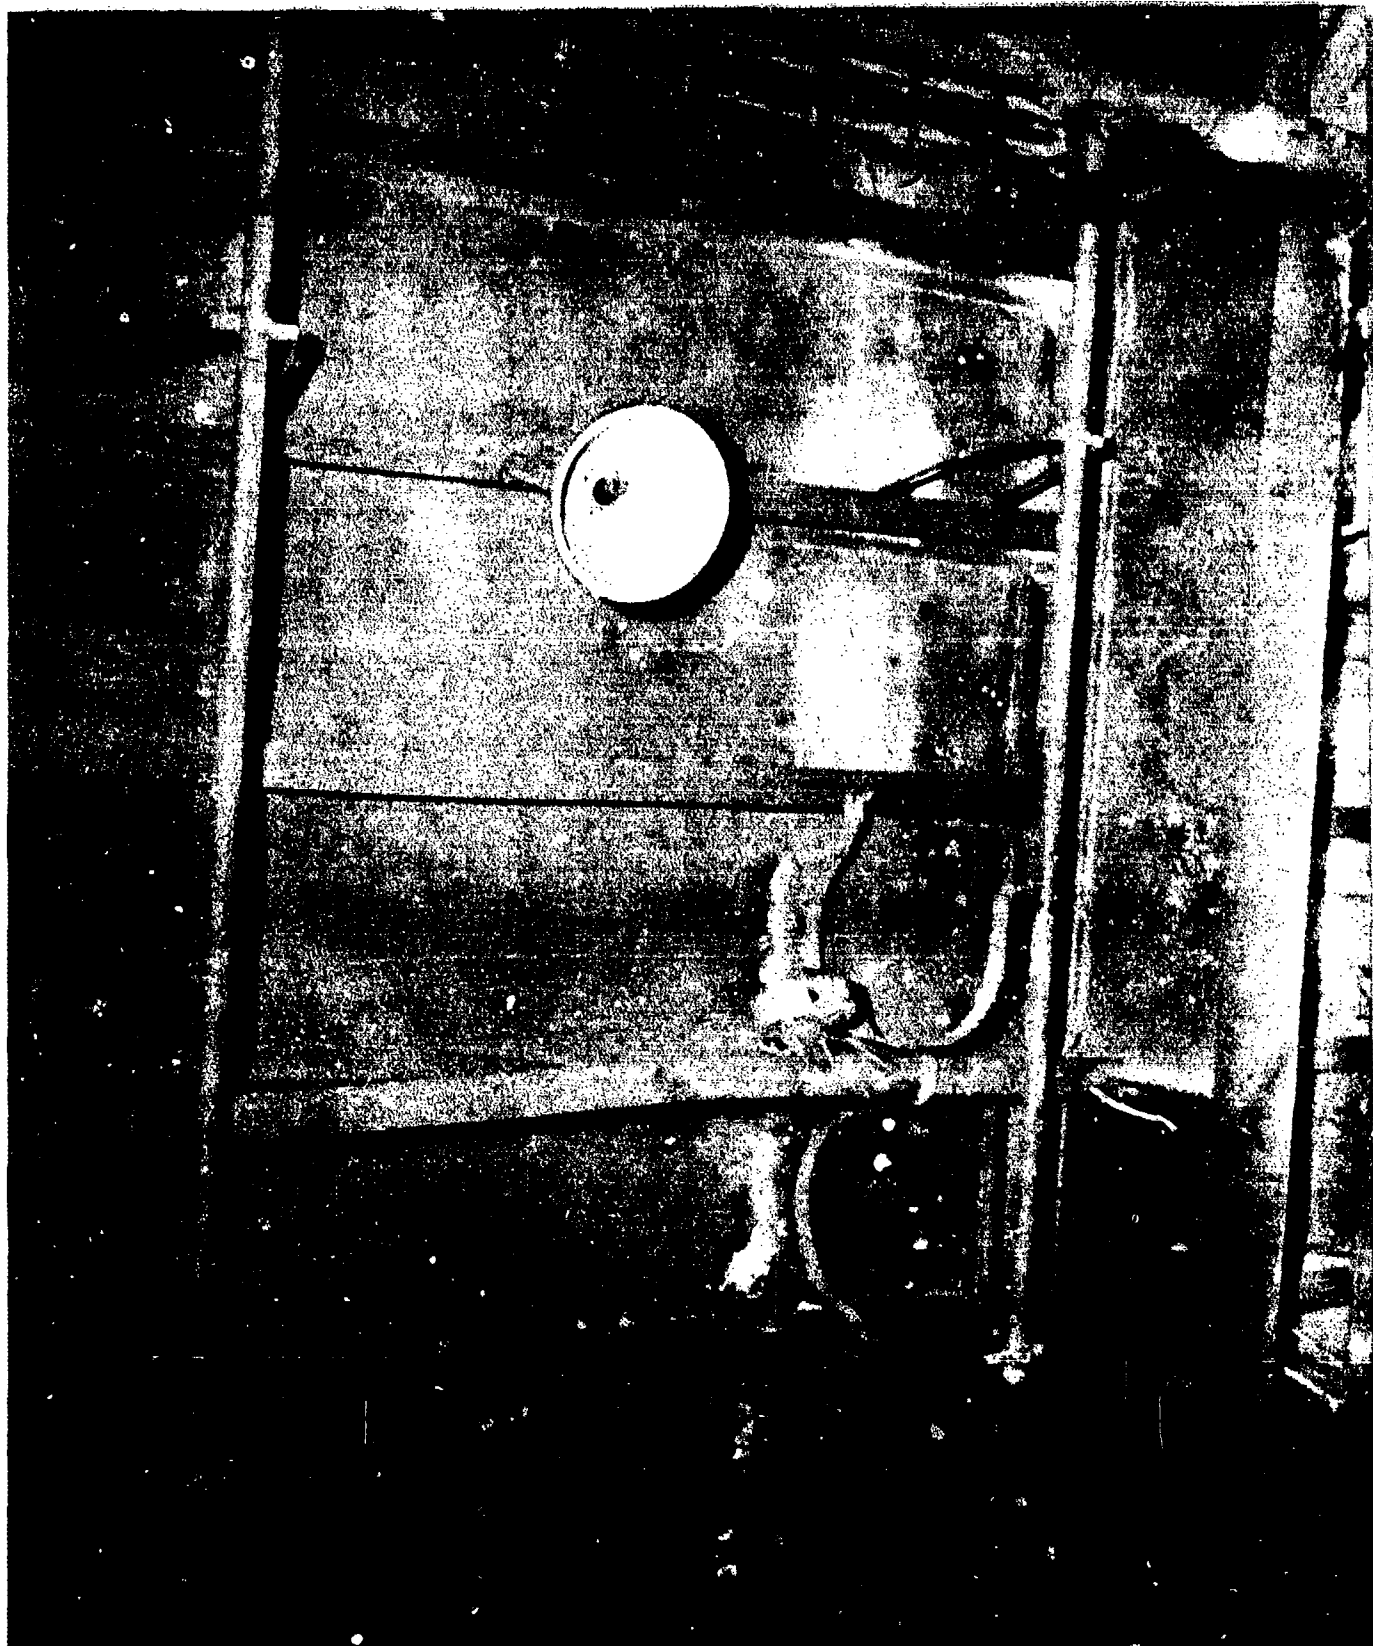
AA-CR-82-1919-5. Damage to lamp in lighting fixture located under flight deck in hangar space, frame 105. View looking up.

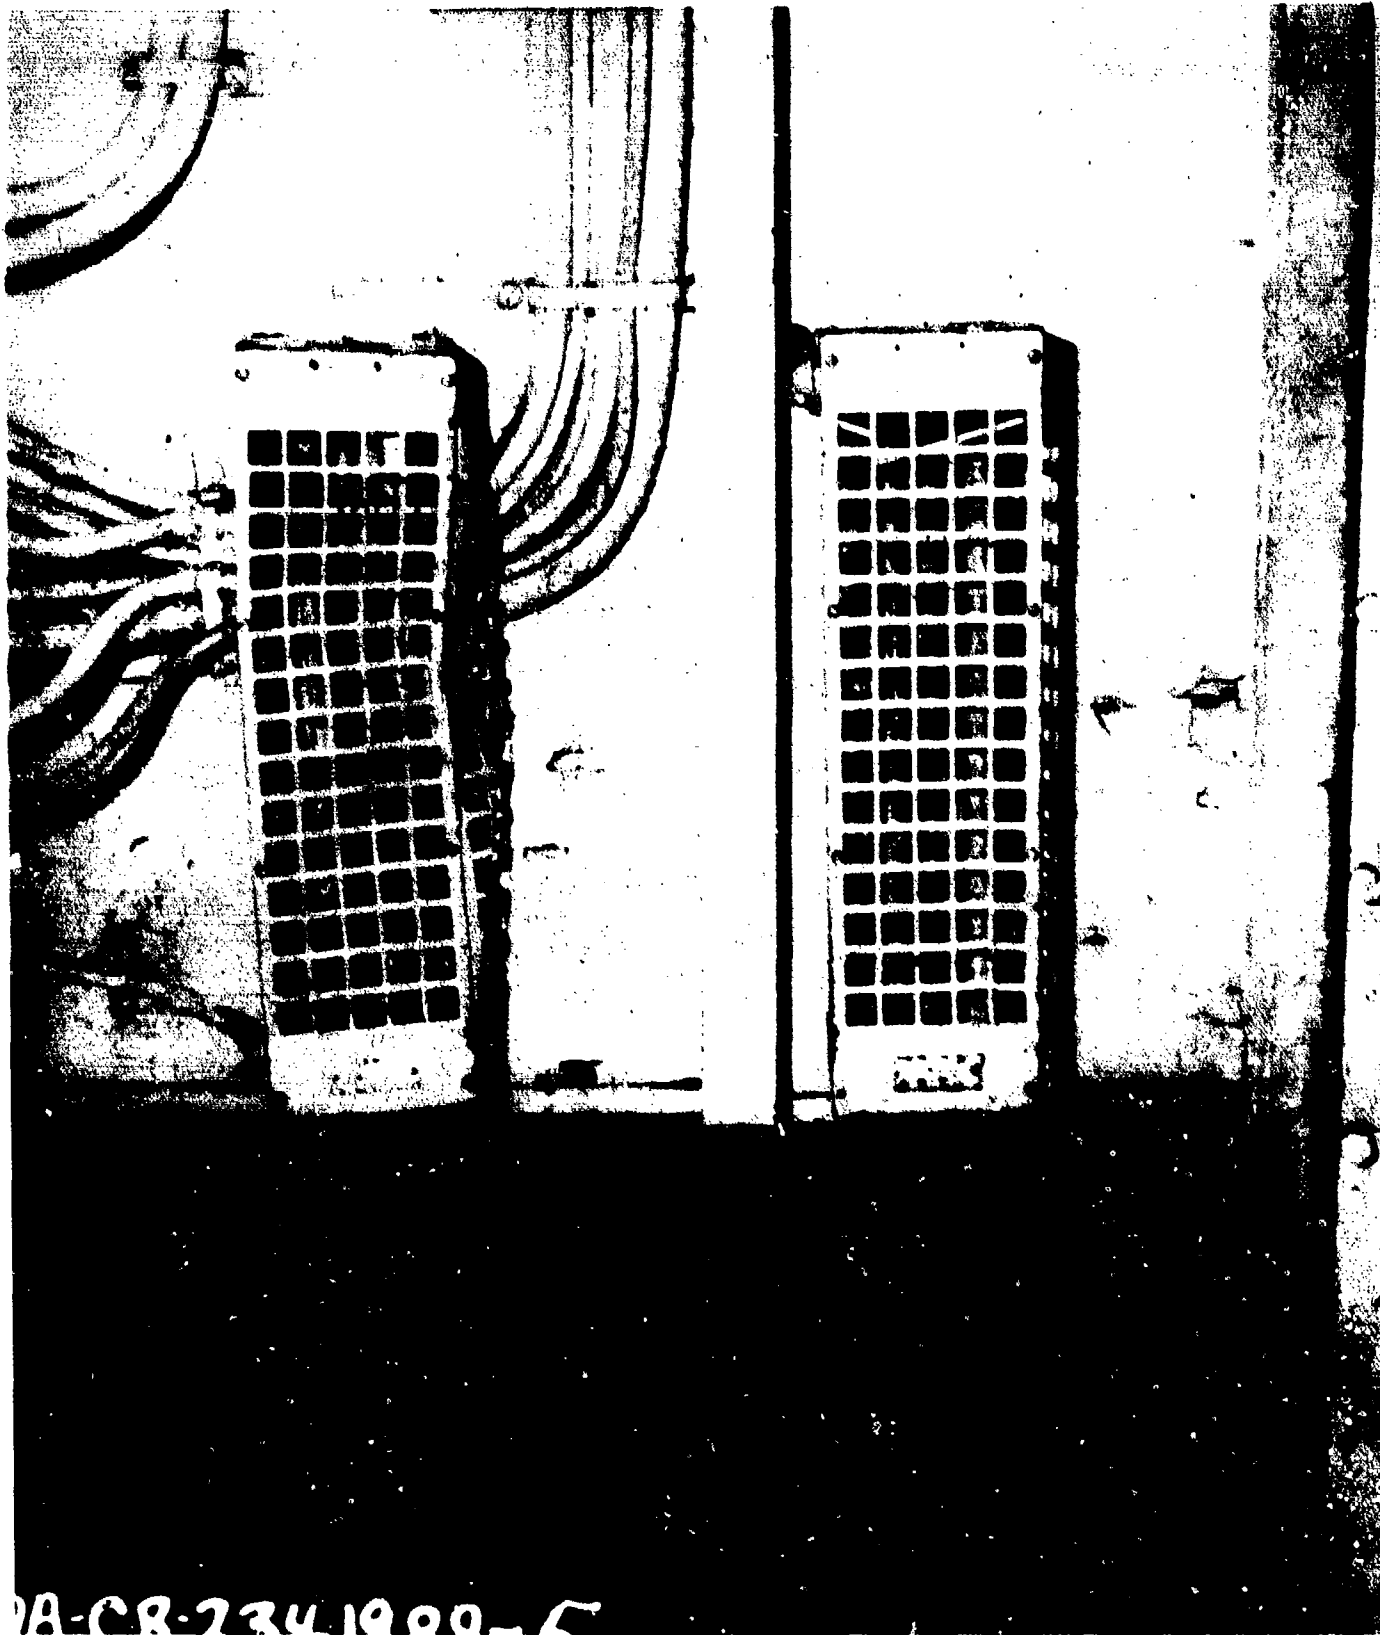
AA-CR-234-1989-5. Damage to non-radiant heater, by loose furniture falling against it. Grids were broken located in aix. Chart house from 51 starboard on gallery deck.
